Lessons Learned from Conservation of Malaysia's Parliament House

By Ar. Zuraina Leily bt Awalludin
Acasys Design & Environmental Architects Sdn Bhd

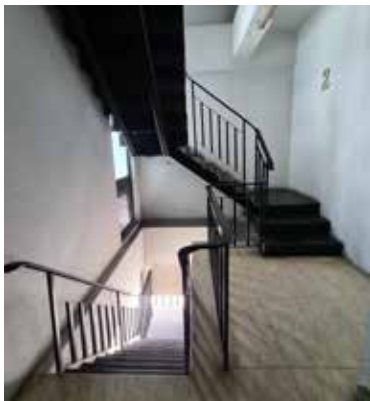
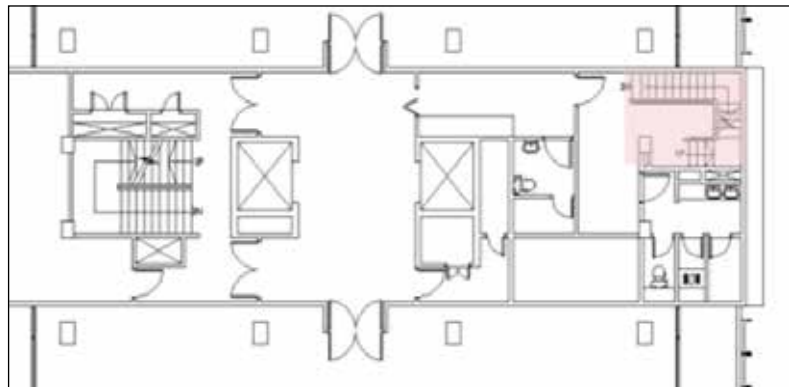
In 1986, major renovations were carried out to the Parliament House to comply with several fire safety requirements and standards as stipulated in the Uniform Building By Laws (UBBL) 1984. This was after the Campbell Complex fire on April 8, 1976 where like most buildings built before the incident had an inadequate fire-fighting system. The 17 storey Tower Block was originally built with only one flight of stairs, which was an open staircase design. To comply with the UBBL 1984 requirements, a second staircase to serve as a fire escape for the entire Tower Block was constructed. The scope of works included redesigning the layout of the Tower Block where 30 toilets had to be repositioned to make way for the new staircase. Demolition work to affected walls and floor slab areas in the Tower Block were done manually with electric hand held tool drills.

Figure 7: The new fire escape staircase at the Tower Block

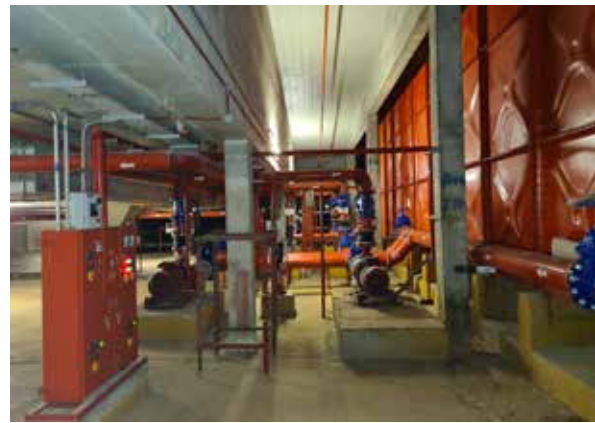
Figure 8: The new mechanical firefighting water tanks

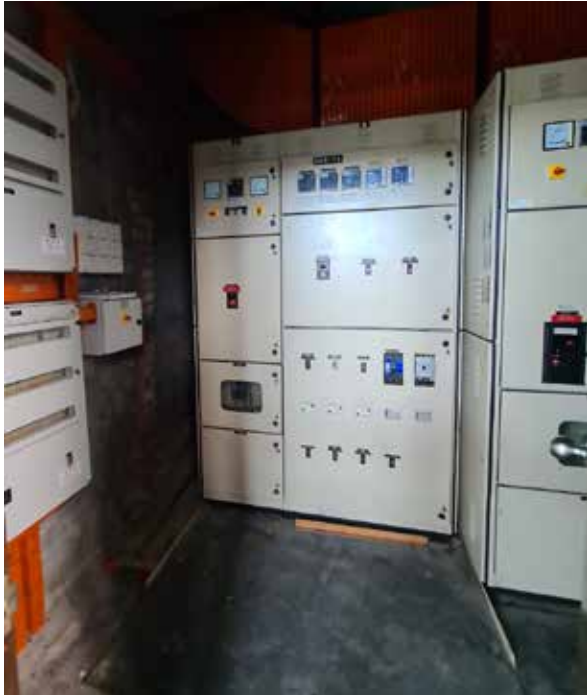
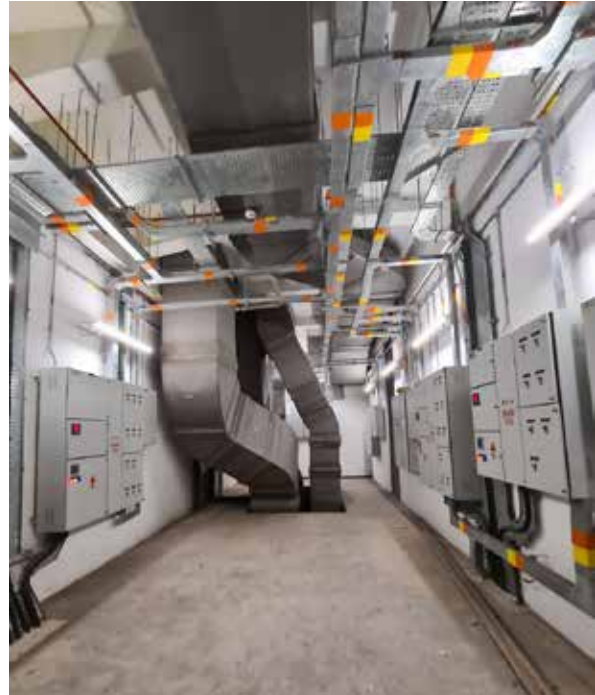
Figure 9: The new electrical sub-switch boards

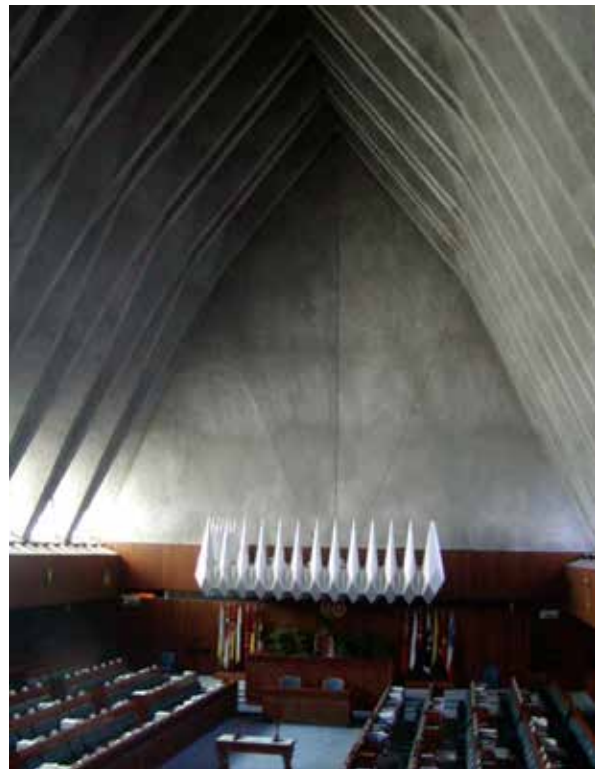
Figure 10: View of internal section of the Pinnacle

tiles. However, there were frequent leakages from the roof, which was above the *Dewan Rakyat*. Below the Pinnacle Roof, the slab was finished with vermiculite gypsum plaster which provided excellent thermal and acoustic insulation properties. After heavy rain, due to the leakages from the roof, patches of wet plaster could be seen on the underside of the Pinnacle Roof. In a few incidences, these wet patches of lightweight vermiculite gypsum plaster became heavy and disintegrated and dropped down from the ceiling and splashed below. In 1988 major water proofing repairs were carried out where the existing plaster and mosaic tiles were removed and replaced with cementitious waterproofing applied by grouting. The air vent at the top area of the pinnacle also had to be closed as rain brought in by high winds occasionally sprayed into the *Dewan Rakyat*. In addition, there were occurrences when birds entered the vent, perched and nested on the internal ledge, and sometimes chirped so loudly that the sound echoed into the hall.

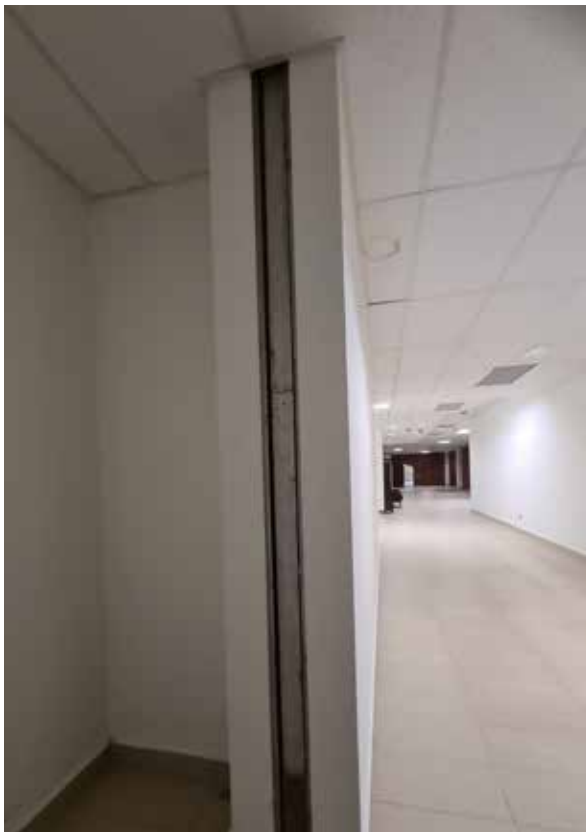
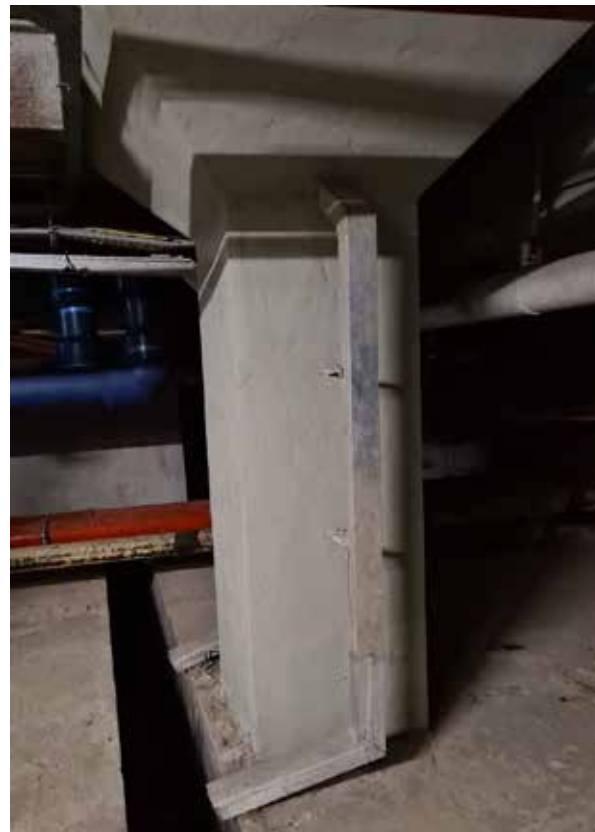
Figure 11: View of the rainwater downpipes

They were generally installed on both sides of all internal columns of the building. After 20 years, the majority of the narrow rainwater downpipes became clogged and ineffective. Rainwater frequently back flowed into the building and caused damage to the existing finishes. Repairs were done and a few of the rainwater downpipes managed to be revived whilst others, which were badly clogged, were sealed and drainage diverted to the perimeter of the roof.

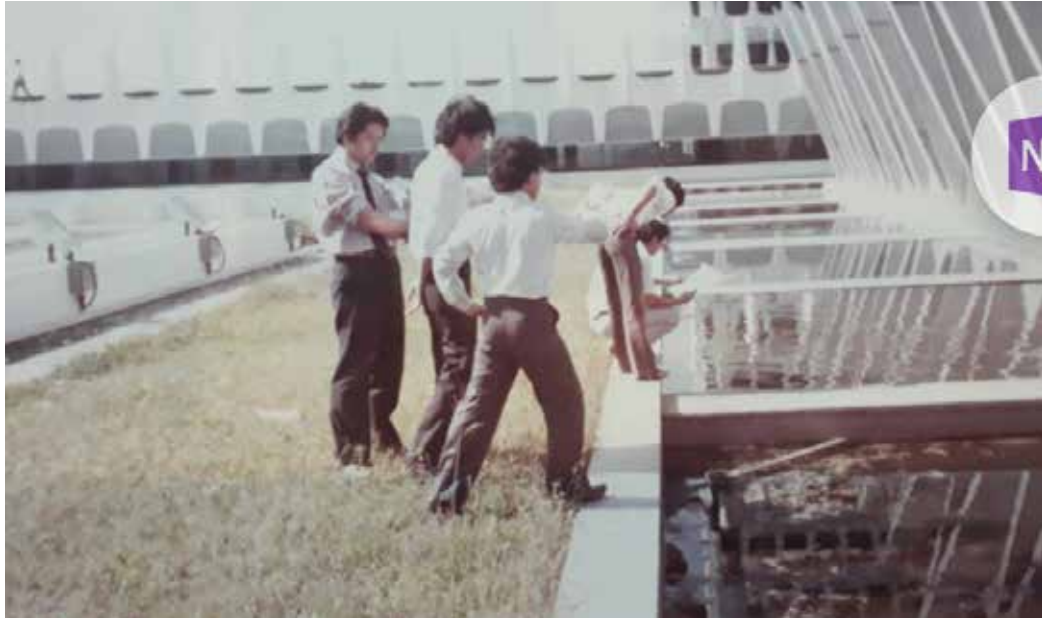
Figure 12: View of pool and grass area at the lower rooftop in 1987

Over the years, frequent leakages seem to occur even after waterproofing works were done on the roof in the water pool areas. There were instances when water leaked in from the roof slab, flooding the *Dewan Rakyat* and corridors of the building. This resulted in a temporarily closure of the pool system and replacing it with earth and grass. Efforts to revive the roof pool system failed again even after re-waterproofing and re-tiling works were carried out.

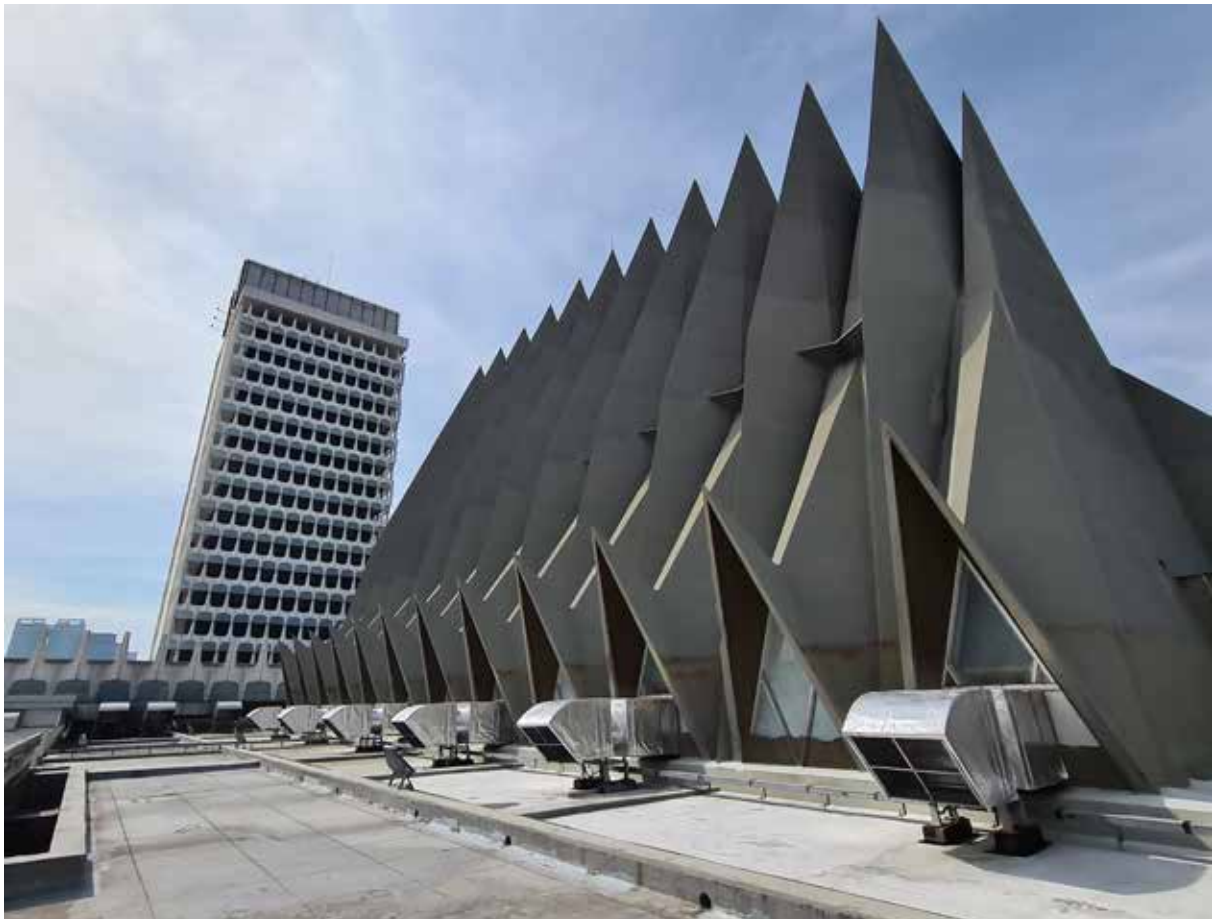
Figure 14: View of the present lower rooftop after waterproofing repairs and omitting the pool system

In 2010, leakage at the Parliament building started to occur again especially at the Pinnacle roof and the surrounding pool roof areas despite the major repairs done in 1988. With the recommendation of the forensic engineers from Kumpulan Ikram Sdn Bhd, the roof areas were redesigned to remove the pools, and redirect

the rainwater runoff on the roof to existing roof drains.
