Lessons Learned from Conservation of Malaysia's Parliament House

By Ar. Zuraina Leily bt Awalludin
Acasys Design & Environmental Architects Sdn Bhd

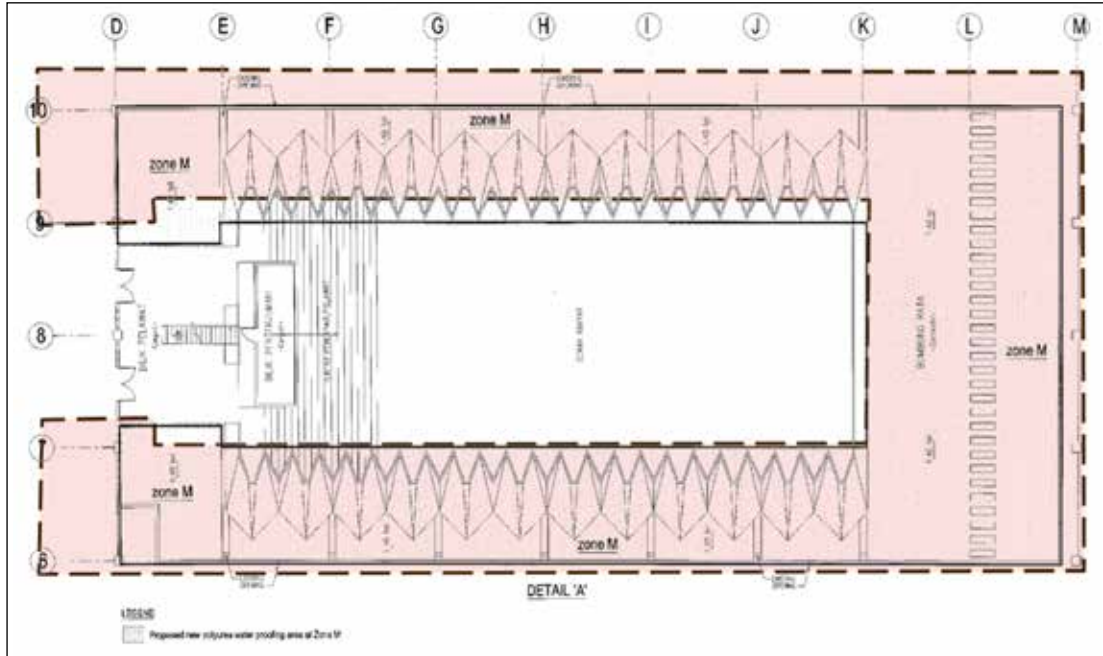
Surrounding the pinnacle's base was a water pool system approximately 450mm in depth which also sat along the roof above the *Dewan Rakyat*. The pool system was designed to provide a reflective and cooling effect inside the building and was connected to other pools inside and outside the building. Through the years, frequent leakage from the roof pool resulted in high maintenance repair costs which eventually led to its closure. Findings by forensic engineers later showed that the concrete strength of roof slabs had deteriorated resulting in hairline cracks

Figure 6: A plan drawing of the pool shaded, surrounding the Pinnacle section
(Photo source: Public Works Department Malaysia)

which caused the leakages into the building during heavy downpour.

Over the years, frequent leakages seem to occur even after waterproofing works were done on the roof in the water pool areas. There were instances when water leaked in from the roof slab, flooding the *Dewan Rakyat* and corridors of the building. This resulted in a temporarily closure of the pool system and replacing it with earth and grass. Efforts to revive the roof pool system failed again even after re-waterproofing and re-tiling works were carried out.

In 2010, leakage at the Parliament building started to occur again especially at the Pinnacle roof and the surrounding pool roof areas despite the major repairs done in 1988. With the recommendation of the forensic engineers from Kumpulan Ikram Sdn Bhd, the roof areas were redesigned to remove the pools, and redirect

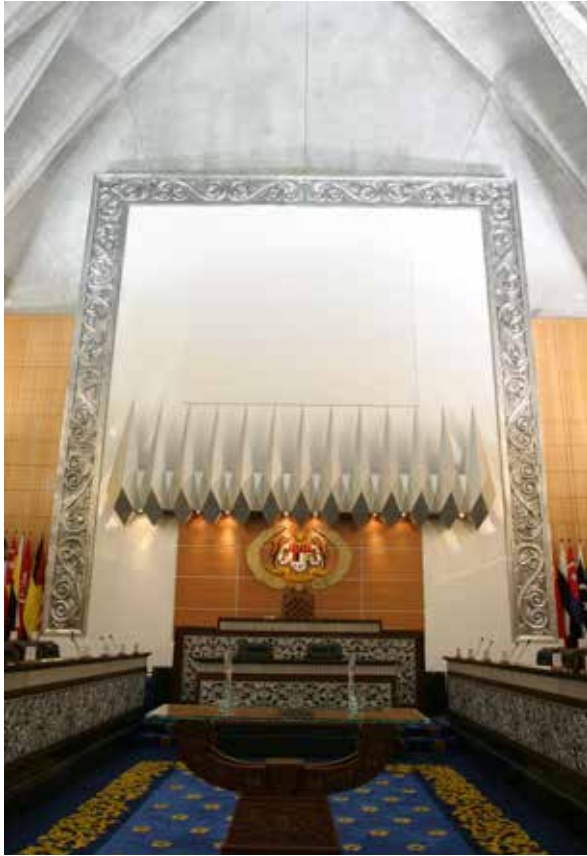
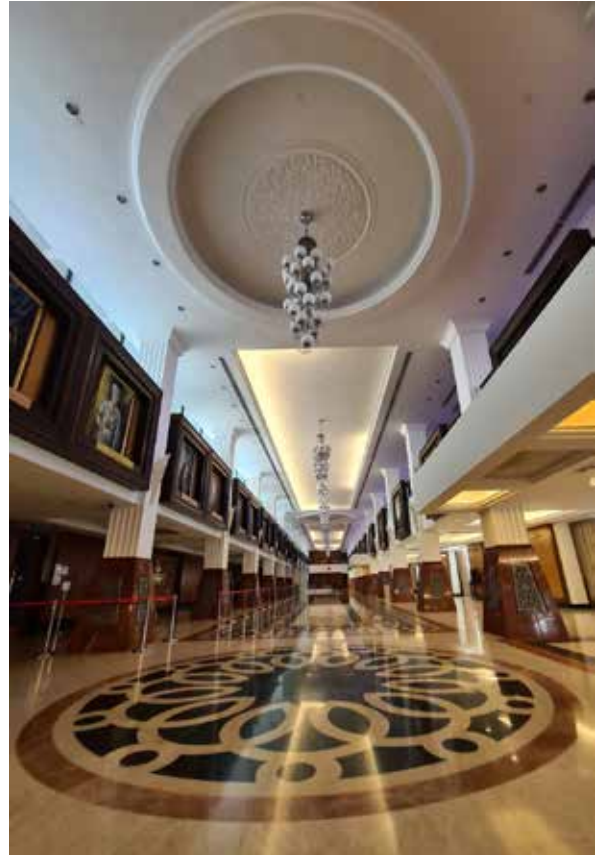
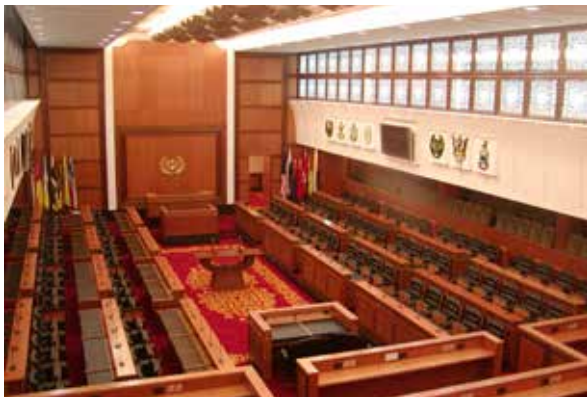
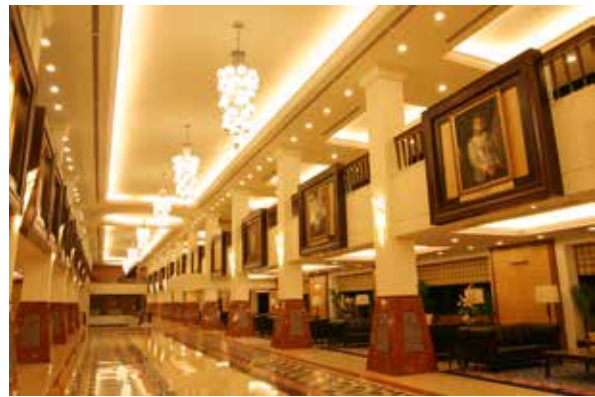
Other than repair works to fix damage mostly caused by leakages and termite attacks, the *Dewan Rakyat* and *Dewan Negara* were renovated and refurbished to cater for the delineation of boundaries. Other areas in the entire Main Block and Tower Block including the lobby, cafeteria, library, Administration Office and Speakers Office were also refurbished.

Figure 13: Renovation and Refurbishment Works
